1<sup>st</sup> Int. **C**onf. On **A**pplication of **A**ir **Q**uality in  
**S**cience and **E**ngineering **P**urposes  
**ICAAQSE 2020** - Kuwait

*Prof. Dr. Mohamed Abdel Raouf El-Gohary*

# Air Quality and Its Impact on Indoor and Outdoor Archaeological Sites: **Luxor museum** (Egypt) and **Amman castle** (Jordan) as case studies

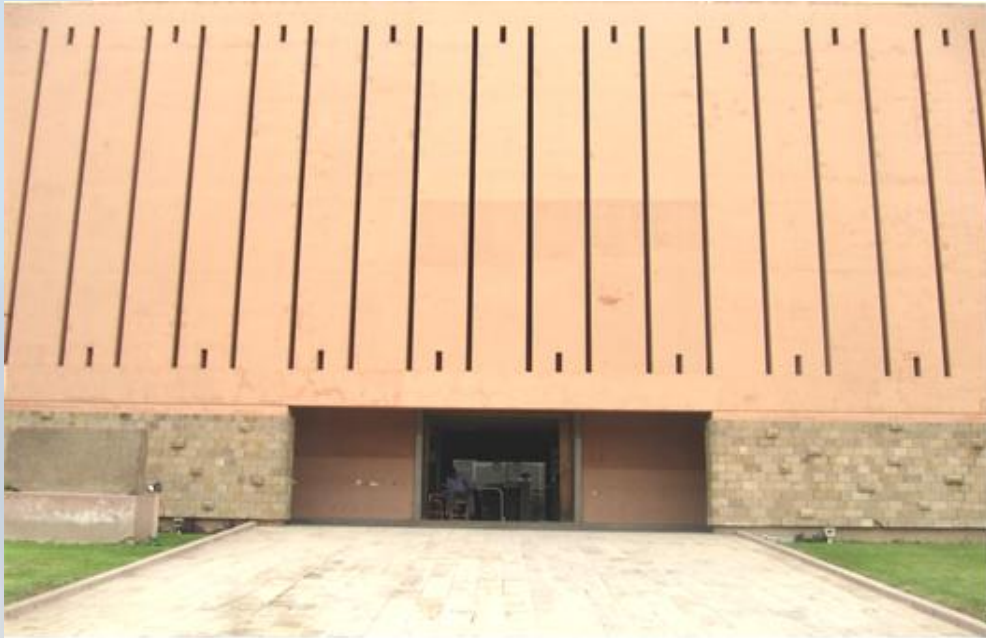
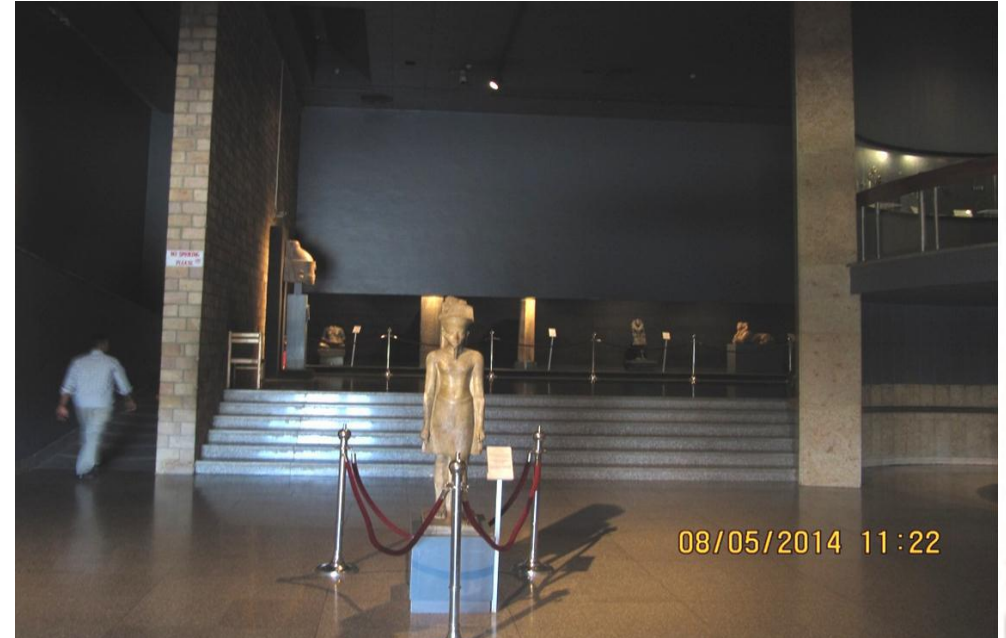
Lies in the heart of Luxor between Karnak and Luxor temples, on the east bank of the Nile, facing the Theban Necropolis. It is prone to the damage of its materials by several types of gaseous and pollutants. Furthermore, the cultural property inside the museum can be threatened either by outdoor pollutants, such as car exhausts, or indoor pollutants generated from sources within the museum, such as fumes from cleaning products. All of these factors cause some aggressive pollutants, such as TSP, fuels, dust, oxides, organic materials, hydrocarbons, and some effective gases. These factors and related mechanisms have resulted in many deterioration forms.

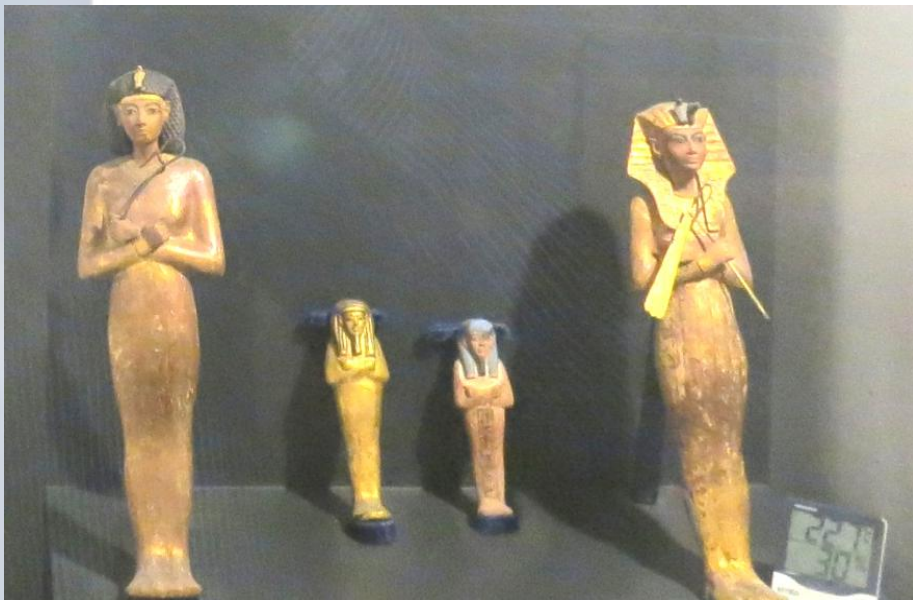
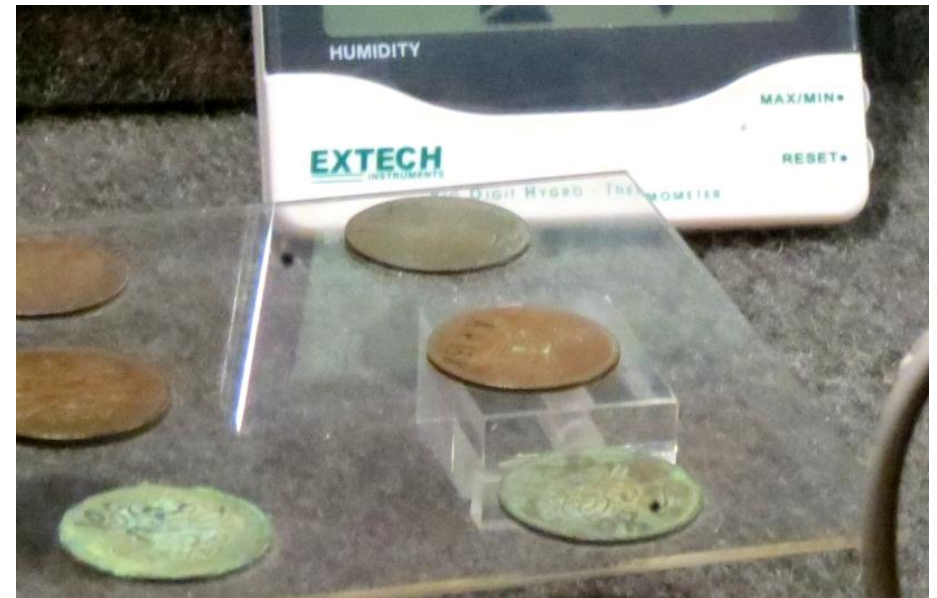
*Metal corrosion bronze and cooper alloys*

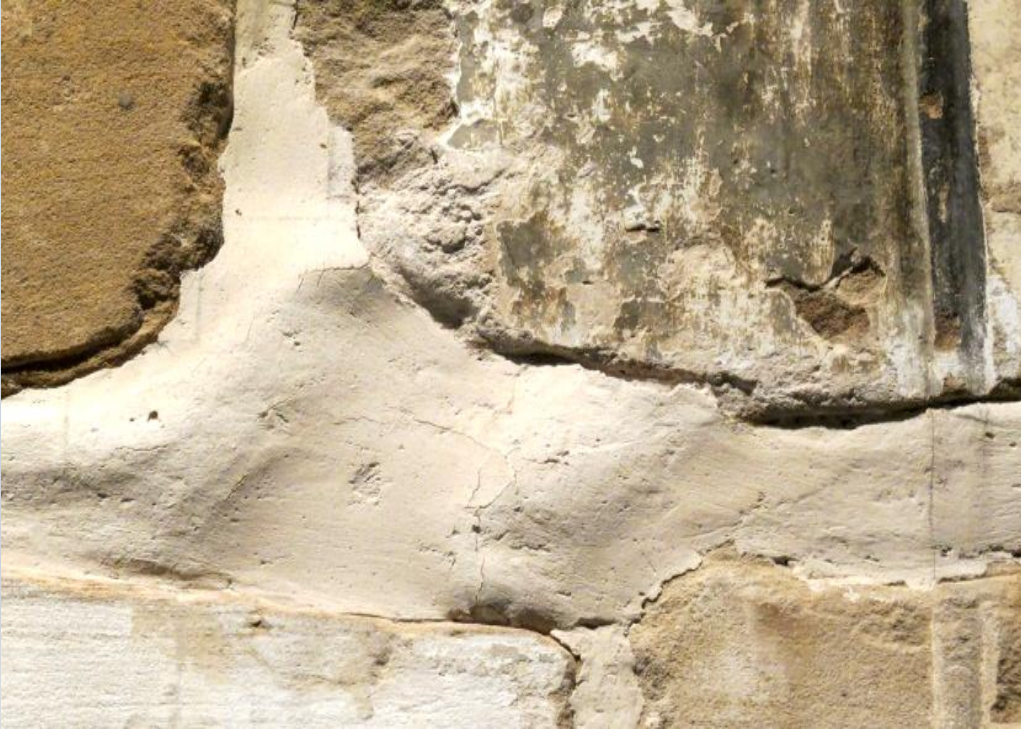
*Salt crystallization & Flaking of  
stone artefacts*

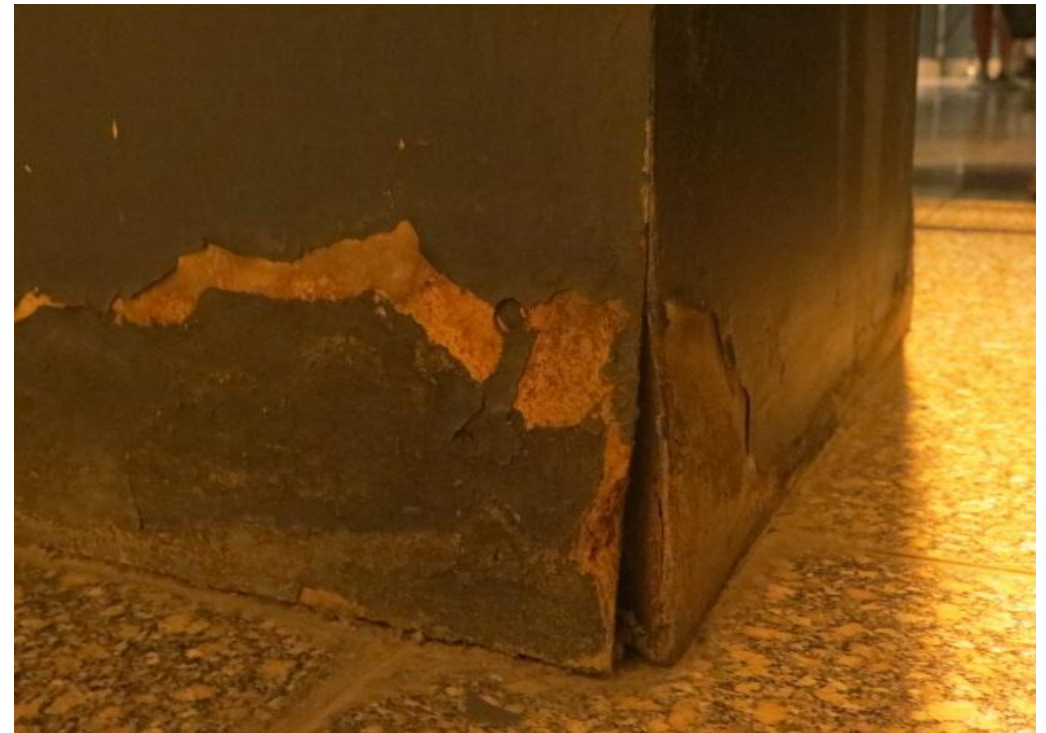
*Metal corrosion bronze and  
cooper alloys*

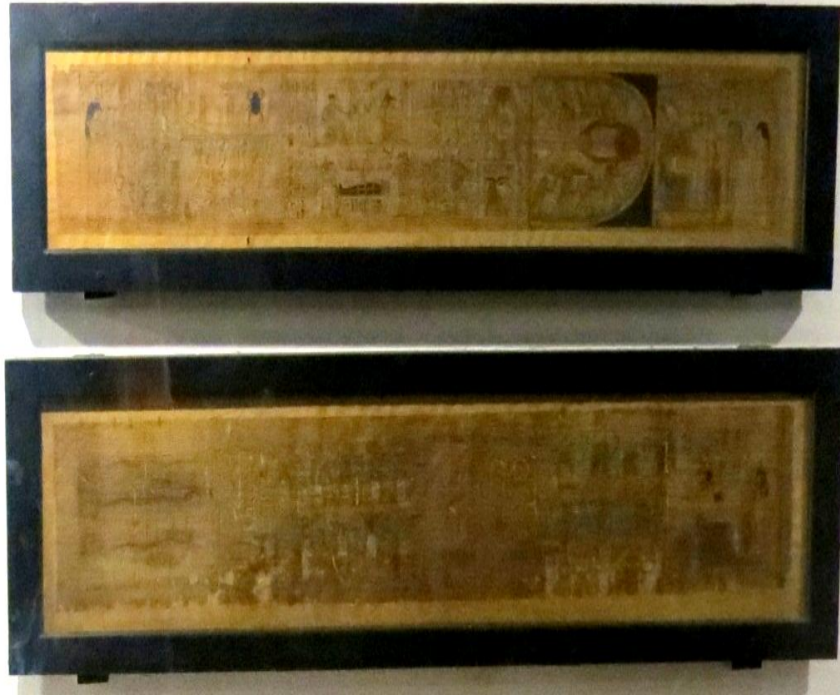
*Embattlement and discoloration of the papyrus*

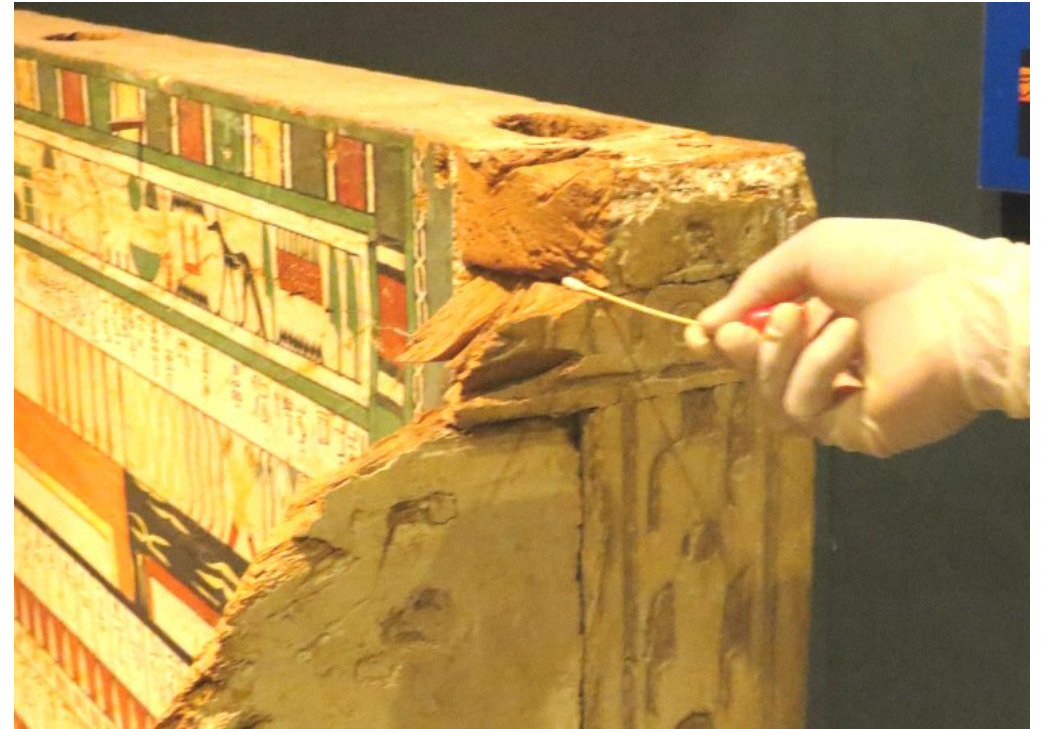
*Mechanical deterioration of wood related to thermal expansion & living organisms*

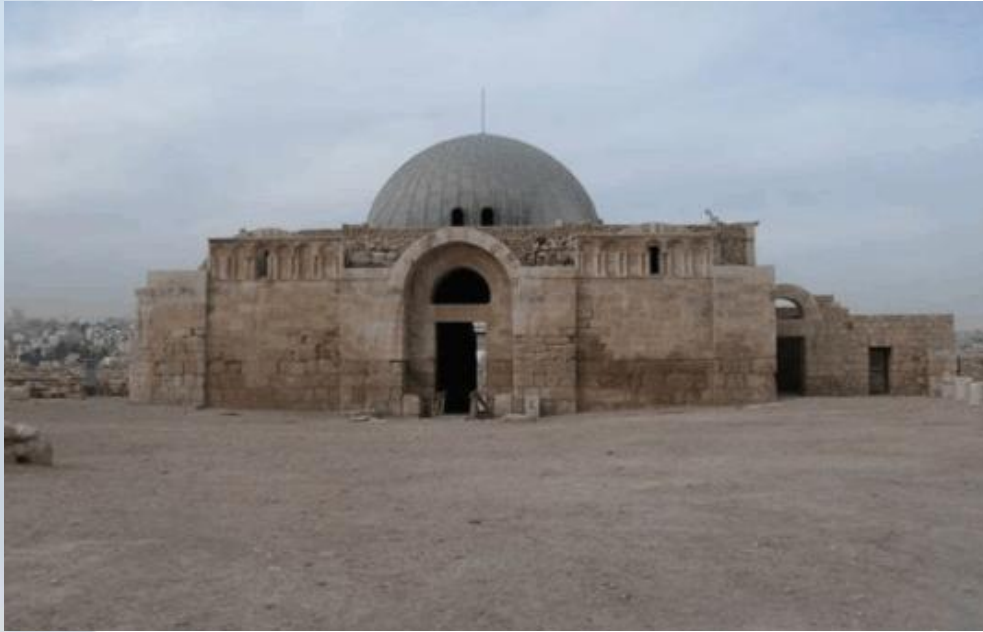
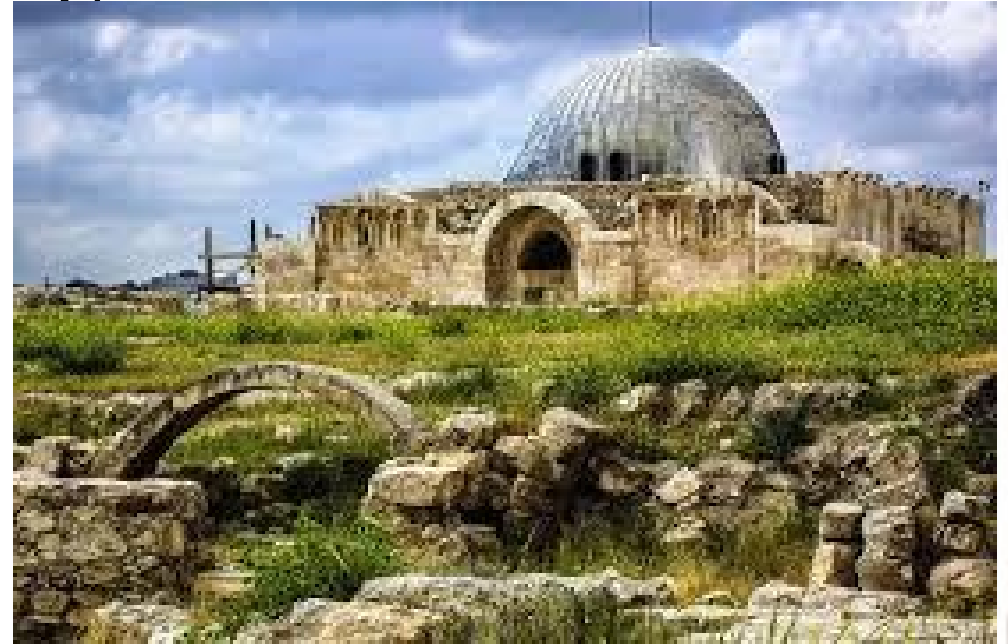
It is the most famous archaeological site in Amman with its complicated buildings extending over several eras beginning from the 2<sup>nd</sup> Iron Age to the Islamic period. It has a plain shape from the north-west to the south-east surrounded by many valleys from all directions except the northern one, which faces Al-Hussein Mountain. It includes many archaeological sites characterized by many artistic features, such as the Open Historical Lake, Umayyad Houses, and Umayyad Liwân “the topic of our study”. It has been affected by different sources of pollution that could be divided into stationary sources and mobile sources.

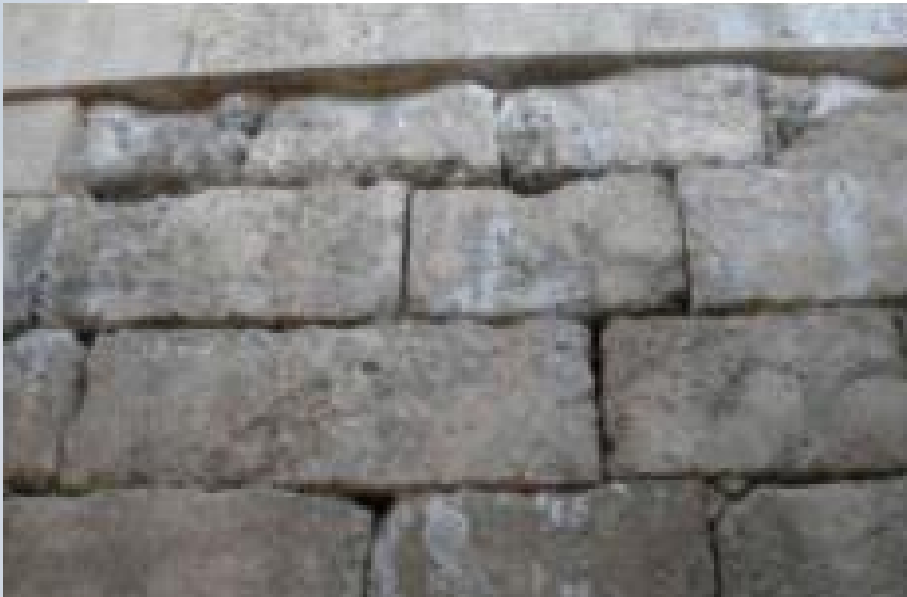
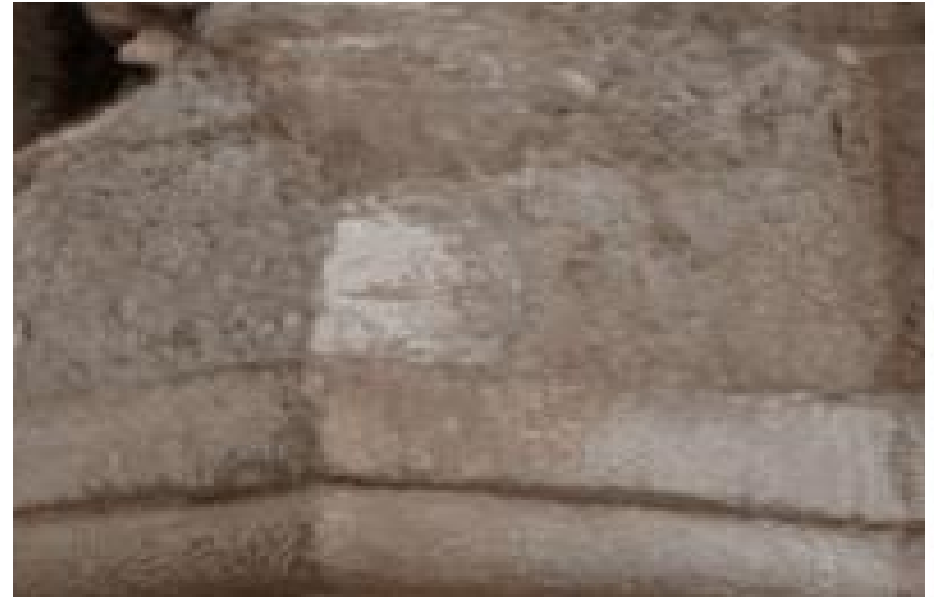
*Severe etching and loosing of calcite grains on the stone surface  
due to dissolution processes by acid rains*

- 2) **Moderate polluted surfaces** mostly caused by **corrosive chemical mechanisms** result from air pollution with other synergetic effects as rainwater or different sources of moisture. For example, we can notice that the sulfate found in some stone surfaces is formed by chemical reactions between  $\text{SO}_x$  and  $\text{CaCO}_3$ , which, leads to the formation of some aggressive salty hard crusts as Gypsum " $\text{CaSO}_4 \cdot 2\text{H}_2\text{O}$ ", which is considered the most ubiquitous salt found as a result of dissolution processes of Calcite " $\text{CaCO}_3$ ".

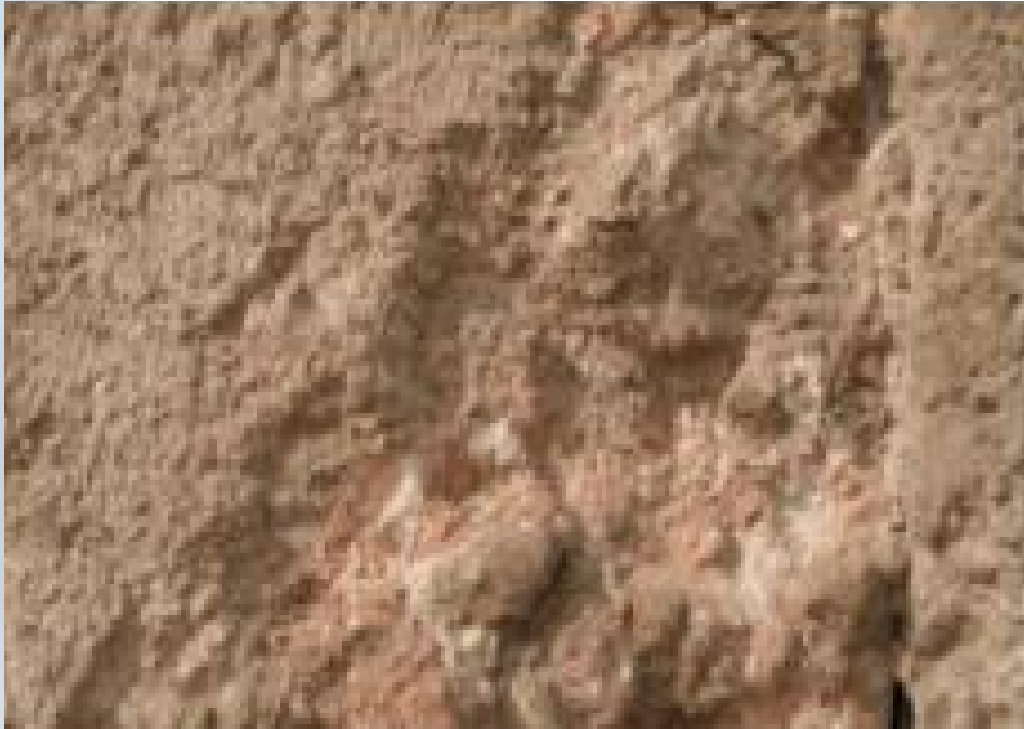
*Presence of colored hard crusts resulting from acid rain, heavy metals dominating the air composition, and fly ashes "ferrous oxides"*

- 3) **Heavy polluted surfaces** are caused by **severe physical and chemical mechanisms**, which resulted from synergetic effects of deterioration dominated in the area and cause many deterioration aspects with severe characterizations, such as **high dark color index** and **high thickness "1.22-1.29 mm"**. These layers are mostly composed of gypsum and anhydrite crusts that are considered common features of carbonated rocks in the polluted area, especially after water evaporation. They cause some crystals of halite, which is considered one of the most aggressive salts that affect limestone surfaces particularly with continuous alternative cycles of wetting and drying.

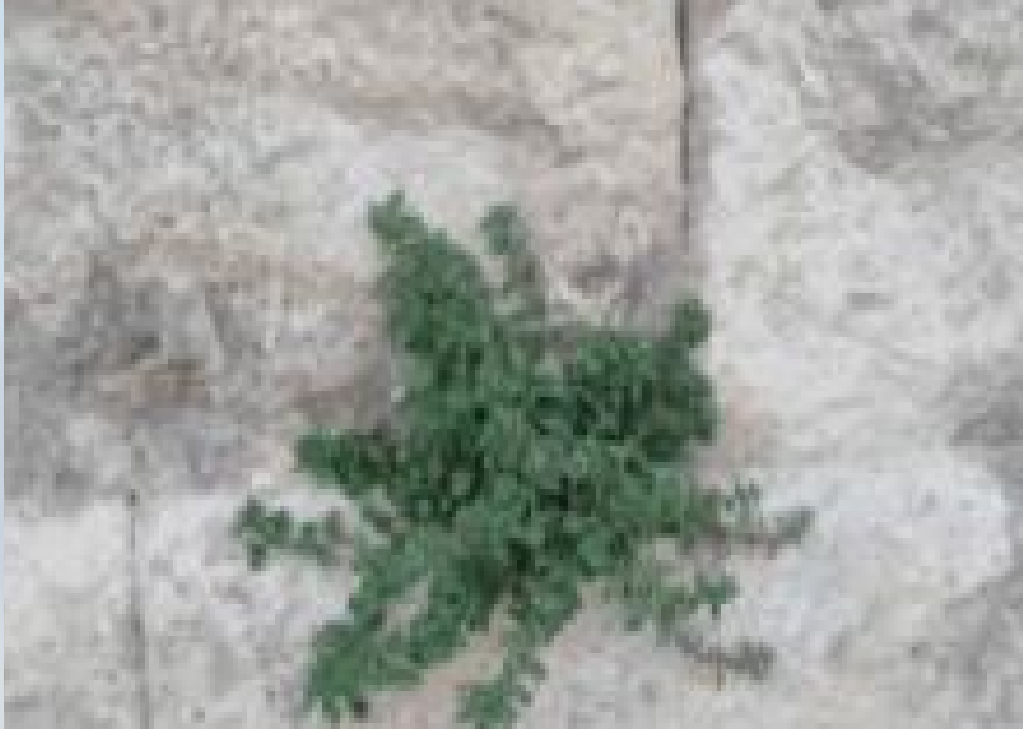
*Eroded of stone surfaces due to botanical and microbiological effects, depending on accumulated pollutants*

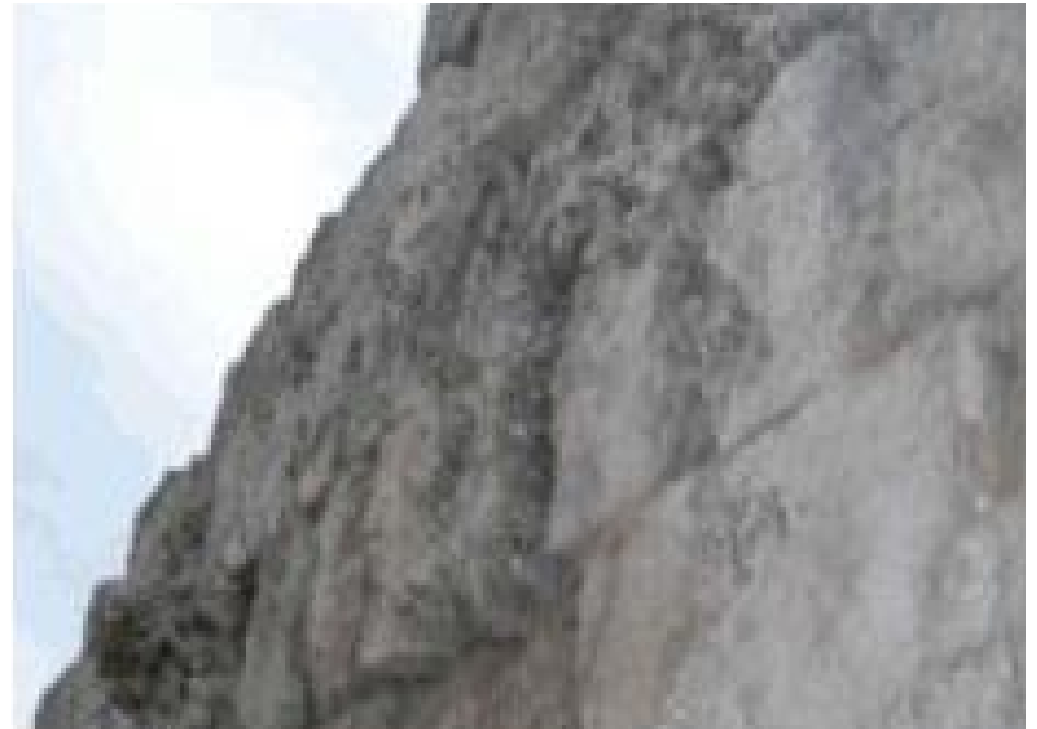
*Discolouring of some zones on the stone surfaces due to soot, dirt, and impurities of polluted oxides*

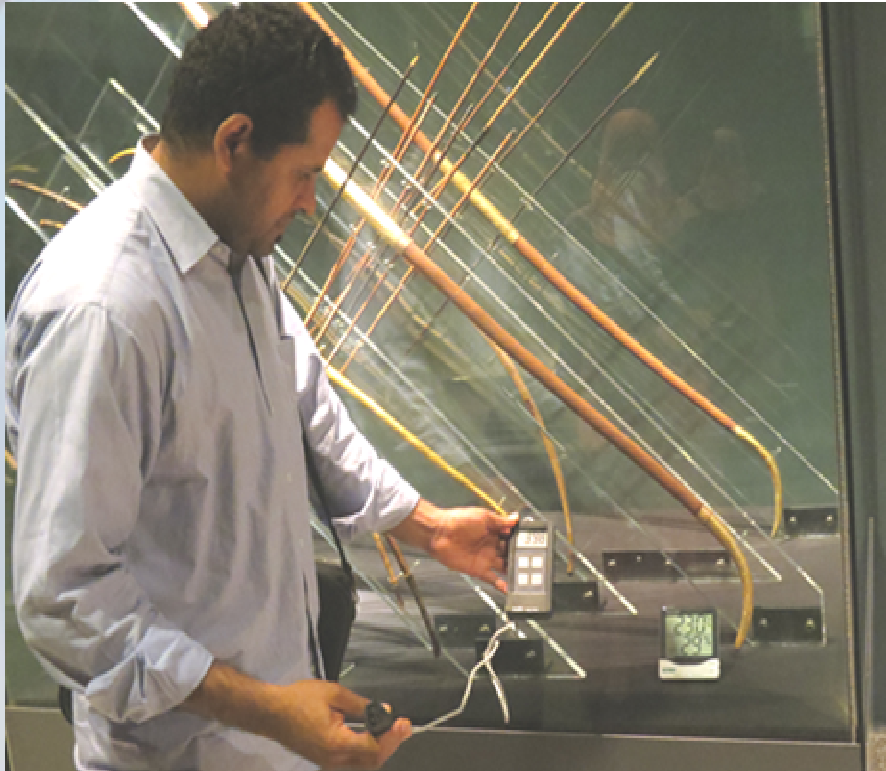
*Measuring AT & (RH) by digital hygro-thermometer*

- **Digital hygro-thermometer** *to evaluate daily AT and RH values.*
- **Passive indicators** *to assess the pollutant levels*
- **PH meter** *to define the acidity of the objects' environments.*

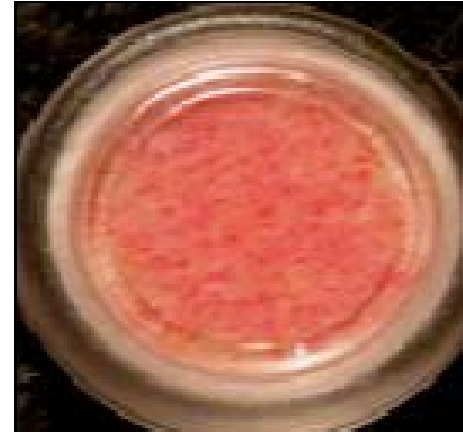
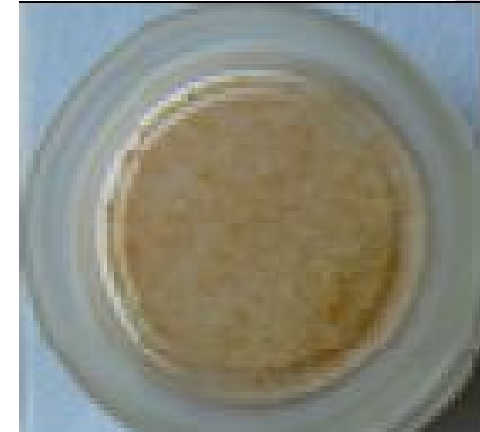
*Measuring of: a) Ammonia, b) Acetic acid c) Acidity, d) Alkalinity by passive indicators*

**In Luxor Museum**, most of the passive indicators give higher results than the average level and suggesting that they require urgent treatment to minimize their level. The average level of ammonia in the open display areas results from the upper unpainted cement concert parts above the artifacts in the old and the new parts of the museum. The other pollutant sources result from car exhaust, Luxor general hospital, internal generators, and natural ventilation. With the high RH value, the alkaline PH value forms alkaline solutions inside the Museum. It causes deterioration of the inorganic and the organic archeological materials, such as the acceleration and degradation of lignin and hemicellulose of wood artefacts. All of these deterioration mechanisms are mostly enhanced by the alternative effects between **A** and **RH** up and down, which led to different related deterioration features.

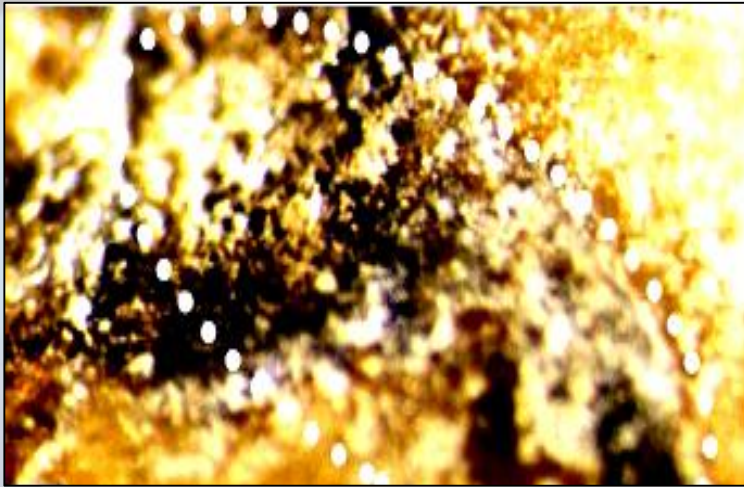
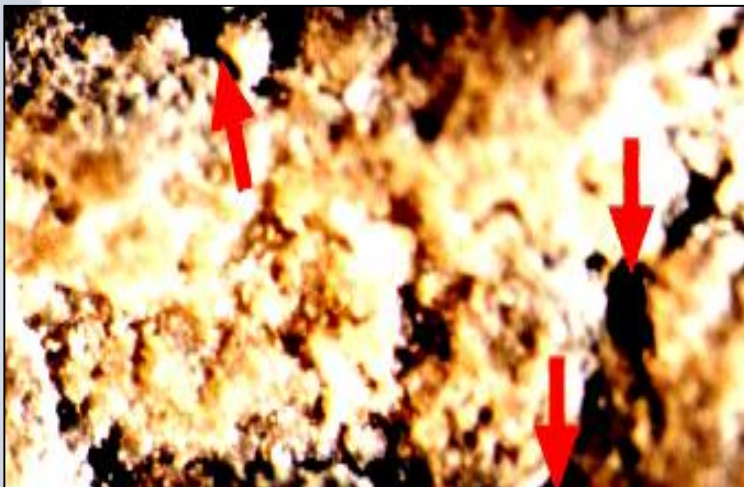
## Deterioration features affected stone surfaces by SM (AC) (2)

*SM shows a. black hard crusts, b. some features of salt efflorescence and sub-efflorescence, c. dissolution and erosion of stone surfaces, d. colored spots and strange grains*
